Sea Link Grid Reinforcement
Pre-Submission Engagement
Suffolk County Council Response

January 2025

Sea Link Pre-Submission Engagement
Suffolk County Council Response
Appendix C: Benhall Railway Bridge
Principal Inspection Report

**BENHALL RAILWAY BRIDGE
BRIDGE No. 59/42
(BRIDGE CODE 1717)
BENHALL**

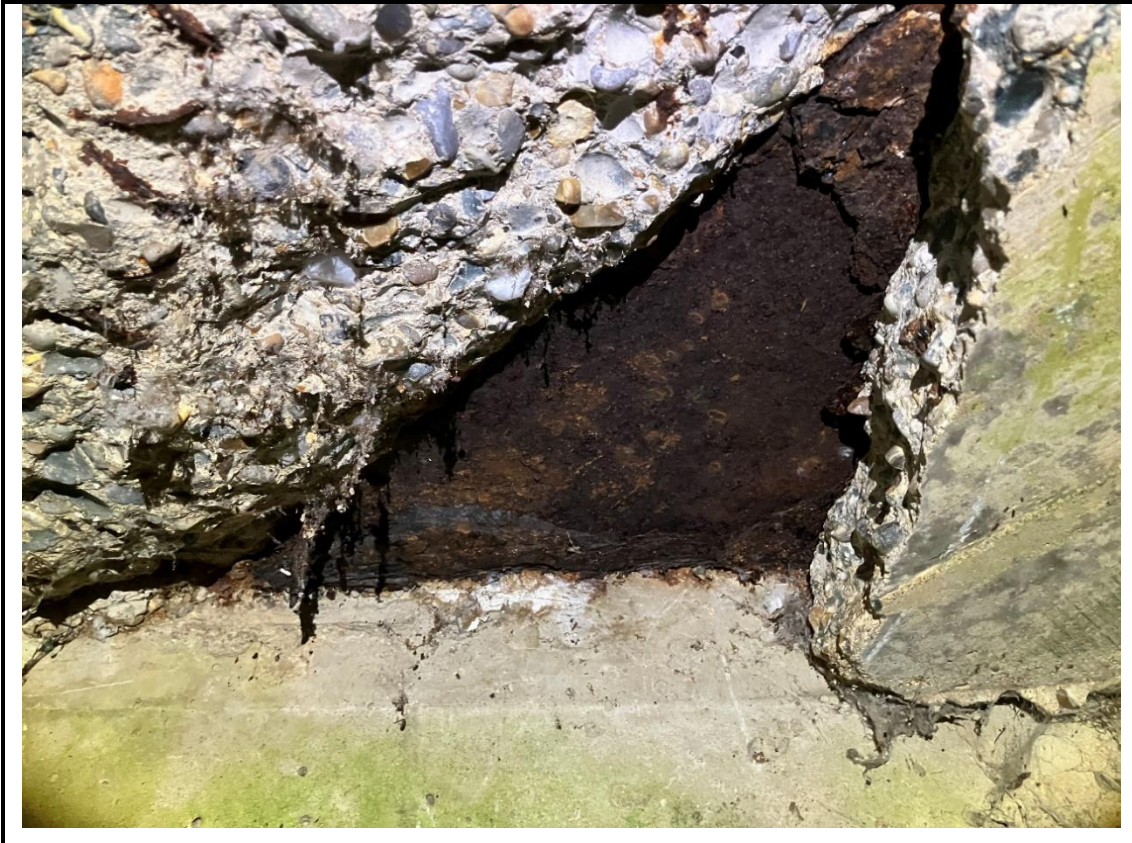
<p>The corrosion to the steel beam is likely due to seepage through the bridge expansion joint and/or failed waterproofing. The defect is at a critical location of the bridge and could lead to shear failure if the defect is not attended to.</p> <p>Previous inspections noted similar spalling defects, but the areas have increased in size and more steel is now exposed.</p> <p>The fact that the spalled concrete areas are adjacent the abutment, where significant leaching/staining is noted to the abutments (see Element 9) and the good cover to steel beams noted, suggests that the cause for this defect is attributable to failed expansion joints and water/moisture ingress.</p> <p>It is recommended that concrete repairs be carried out to the deck to ensure longevity. The steel beams should be cleaned back to sound steel and a protective paint coating applied prior to the concrete repairs. The full extent of corrosion to the steel beams is unknown and should be investigated further prior to detailed design, to ensure suitable remediation. If the extent is relatively small, then cleaning of the steel, protective coating to the steel and concrete repairs to the deck should be sufficient. If the extent is deemed to be significant and potentially affecting capacity, then a more significant deck replacement may be required.</p> <p>The extent of leaching was not measured in the previous inspection and it is a difficult defect to measure, therefore a quantitative comparison cannot be made. However, it is suspected that the defect has deteriorated due to the "fresh" nature of the deposits. The location of the leaching to the soffit and edge beams is indicative of waterproofing failure. It is recommended that the waterproofing be replaced to ensure long term durability of the structure (see Element 17).</p>

There are two areas of exposed steel beam bottom flange identified to the West end of the deck. One area was approximately 200x150mm and the second area 200x100mm, both of which were in the South half of the deck adjacent the West abutment. The exposed areas are showing heavy corrosion and laminated corrosion product flaking off the bottom flange approx. 1mm thick (P5-P7, P9).

It should be noted that this corrosion is at the support location and the exact depth and extents of the corrosion along the beam is unknown.

The previous inspection highlighted minor exposure and corrosion of the steel beam. Based on photographic evidence the extent of the deterioration to date has increased and is now posing a higher risk to the structure.

1717_P5_2024 West abutment/soffit interface – Exposed corroding steel I beam (75mm Cover)

The concrete and steel beam defects should be addressed as one holistic scheme to protect the encased steel beams and ensure longevity of the deck. However, the extent of corrosion to the steel beams is currently unknown and should be investigated further, as this will affect the extent remedial works.

The leaching identified to the abutments and the spalled concrete and exposed corroding steel beams of the deck are attributed to failure of the deck expansion joints. These joints should be replaced as a matter of urgency to prevent further deterioration and before any remedial works to the deck is undertaken. Ideally the joint replacement would be coincidental with the re-waterproofing recommended, if it is confirmed and agreed that only minor concrete repairs are required to the deck.

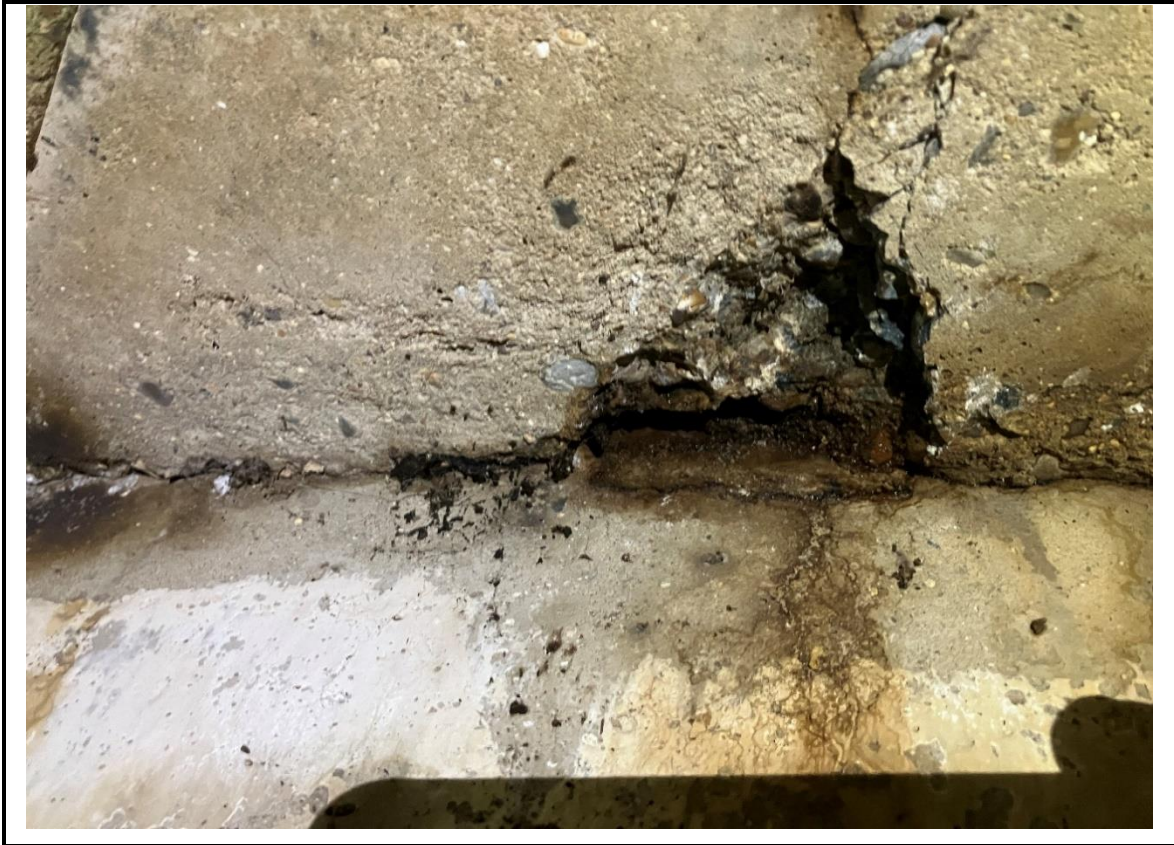
1717_P7_2024 West abutment/soffit interface - Partial spalling & exposure of steel beam

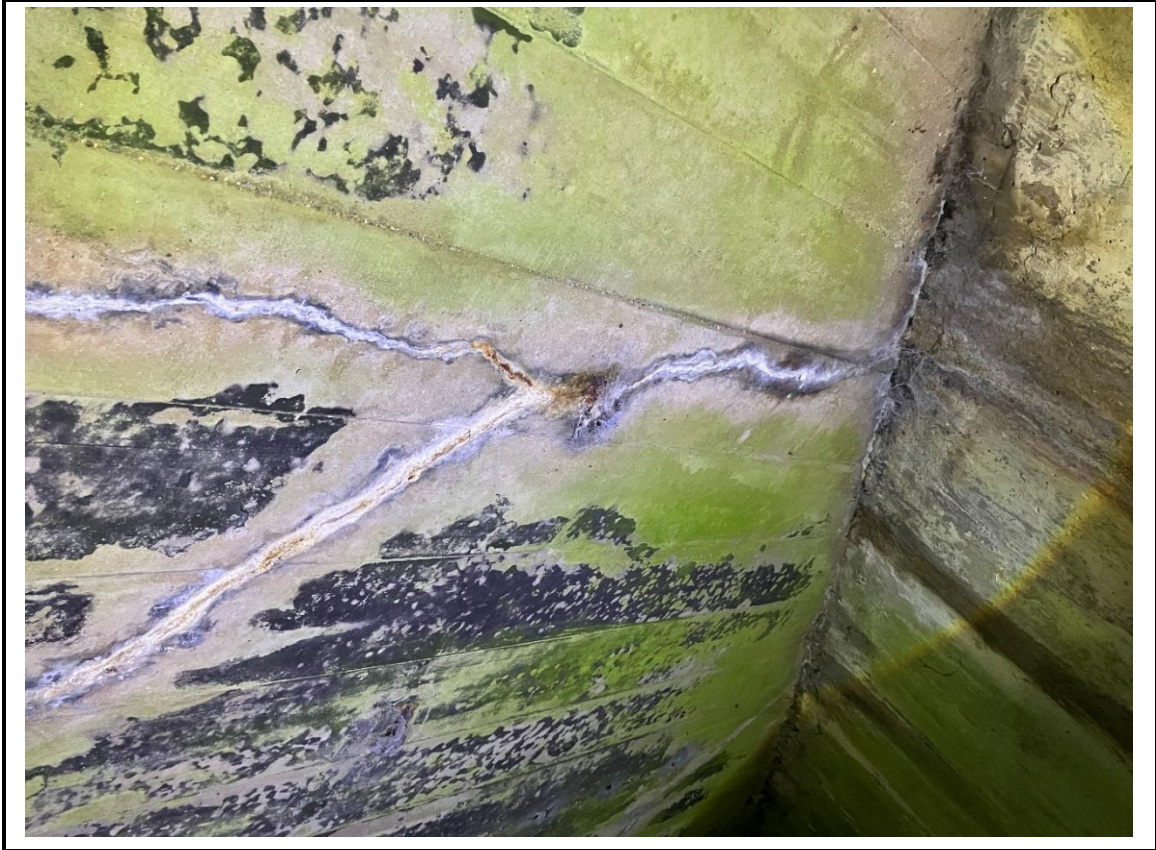
1717_P11_2024 Bridge soffit - Diagonal and longitudinal cracks

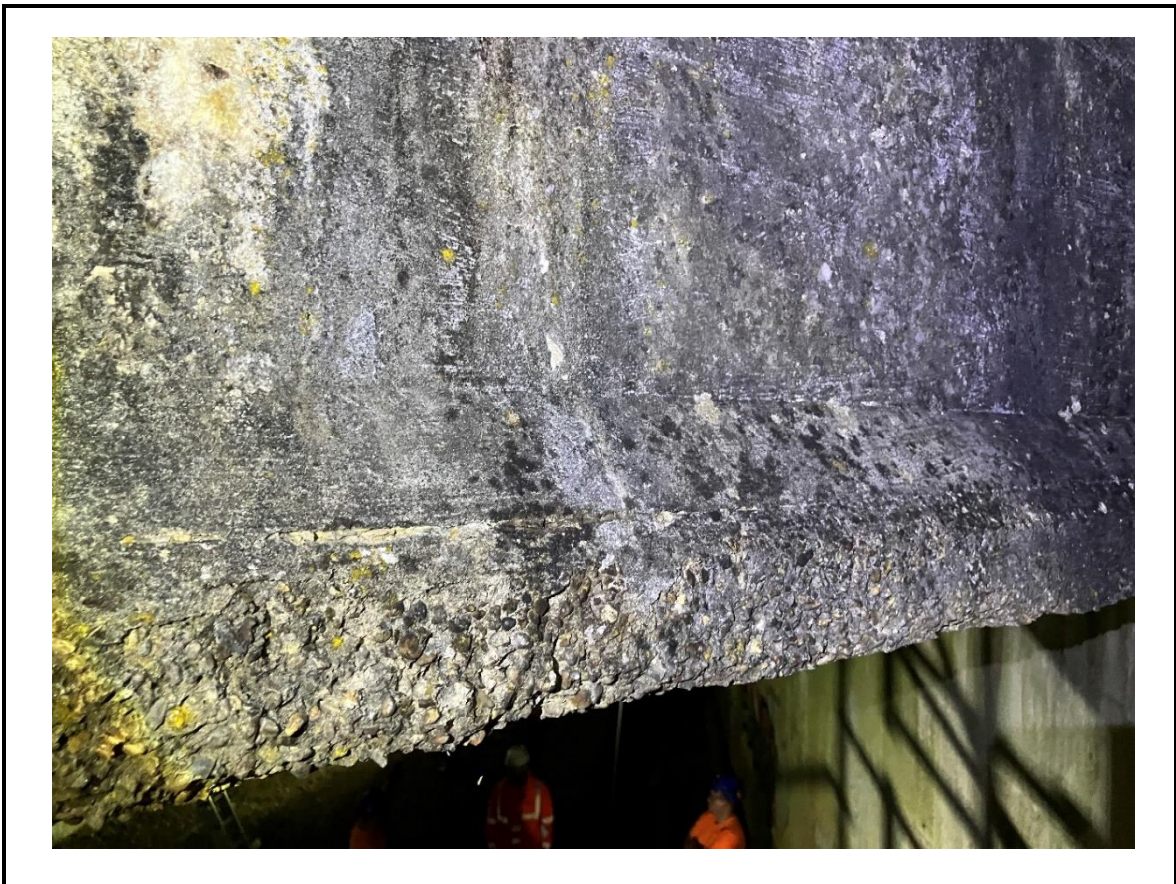
1717_P12_2024 North deck edge – Minor concrete spalling

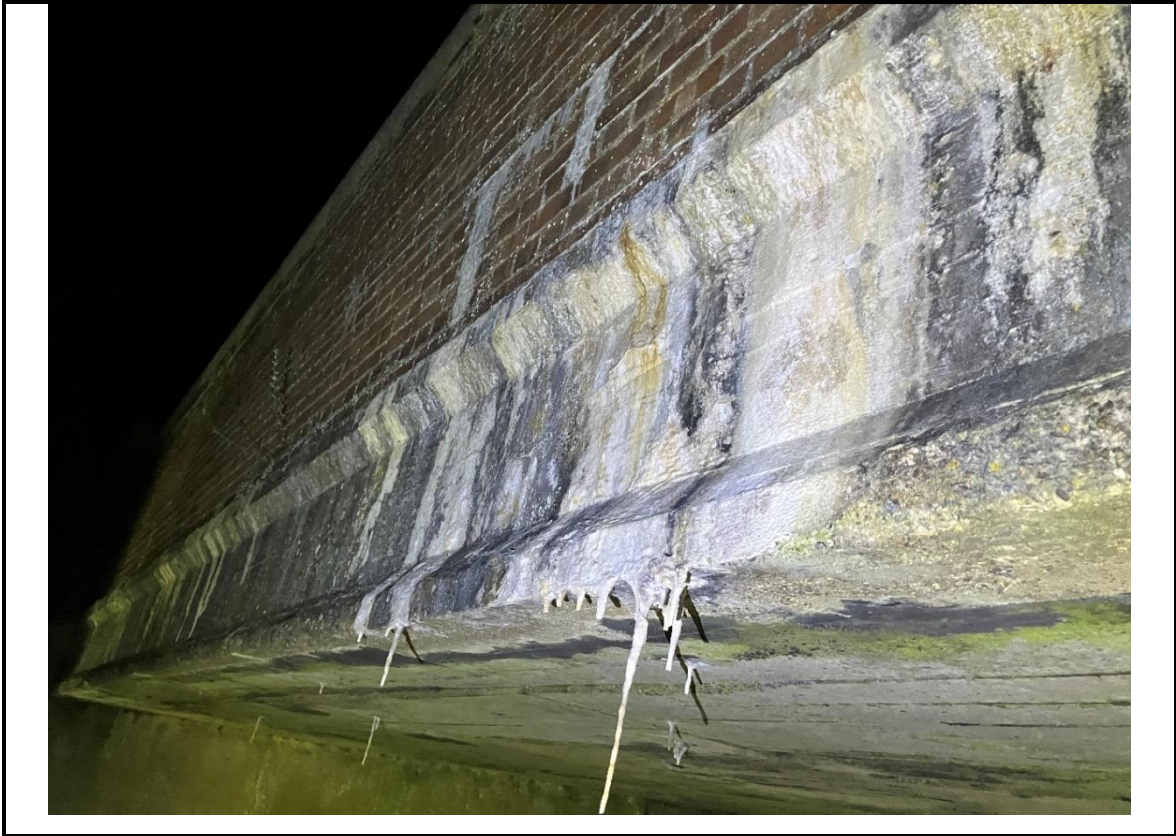
1717_P13_2024 North deck edge - Leachate deposits (<5mm thick) with stalactite build up (also to soffit between beam construction joints)

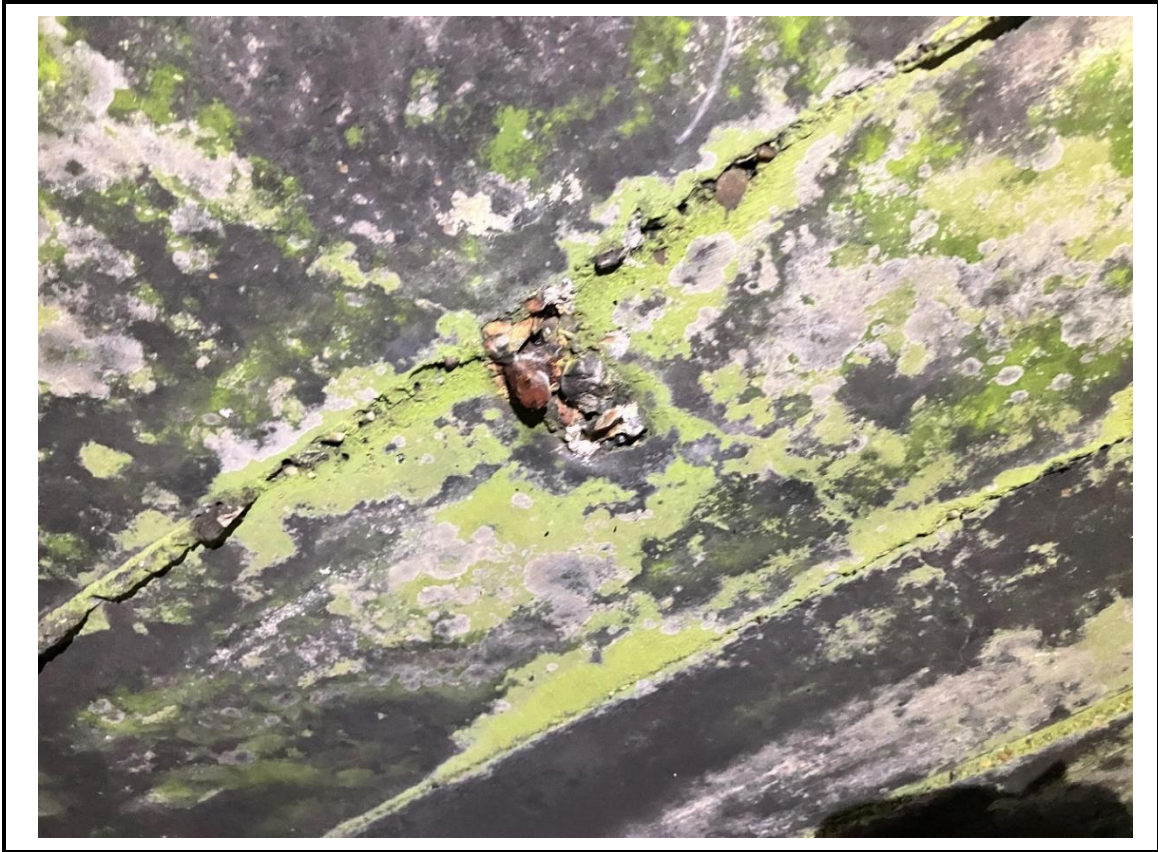
1	<p>There are two areas of exposed steel beam bottom flange identified to the West end of the deck. One area was approximately 200x150mm and the second area 200x100mm, both of which were in the South half of the deck adjacent the West abutment. The exposed areas are showing heavy corrosion and laminated corrosion product flaking off the bottom flange approx. 1mm thick (P5-P7, P9).</p> <p>It should be noted that this corrosion is at the support location and the exact depth and extents of the corrosion along the beam is unknown.</p> <p>There are isolated areas of spalled concrete concentrated at the deck edge adjacent the soffit/abutment interface (P9). The west side of the deck is the most affected compared to the east abutment. The depth of spalling ranges from a depth of 5mm to 75mm exposing the beam flanges (see Element 1). An isolated area of honeycombing was noted running along the full length of a construction joint (P14) and an isolated area of corroded threaded bar to the middle of the soffit (P15).</p>

1717_P15_2024 Bridge soffit – Exposed corroded threaded bar

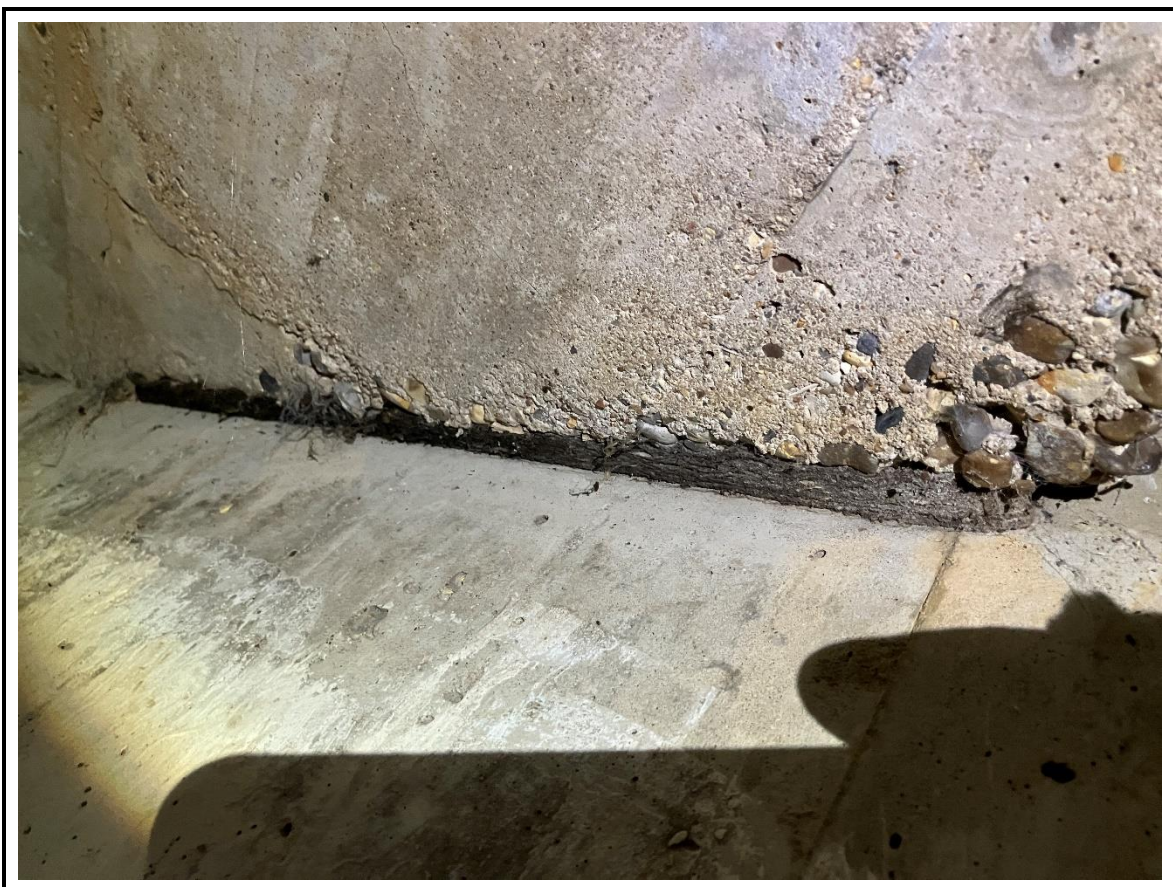
1717_P16_2024 Abutment/soffit interface – Deteriorated filler board

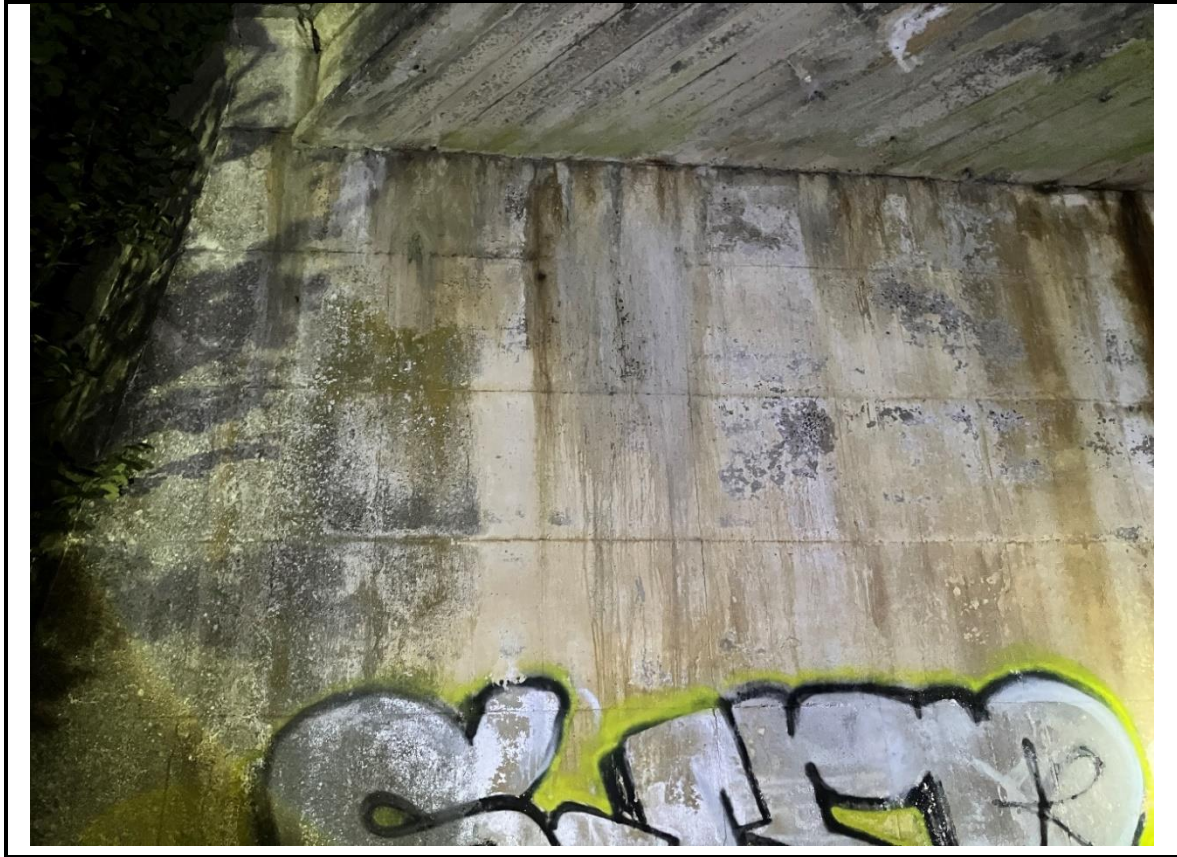
Both abutments were marked with historic and fresh saline leaching and corrosion staining throughout their entire length. This is likely to be a result of failure of the expansion joints above (see Element 18).

1717_P17_2024 West abutment – Saline leaching and corrosion staining

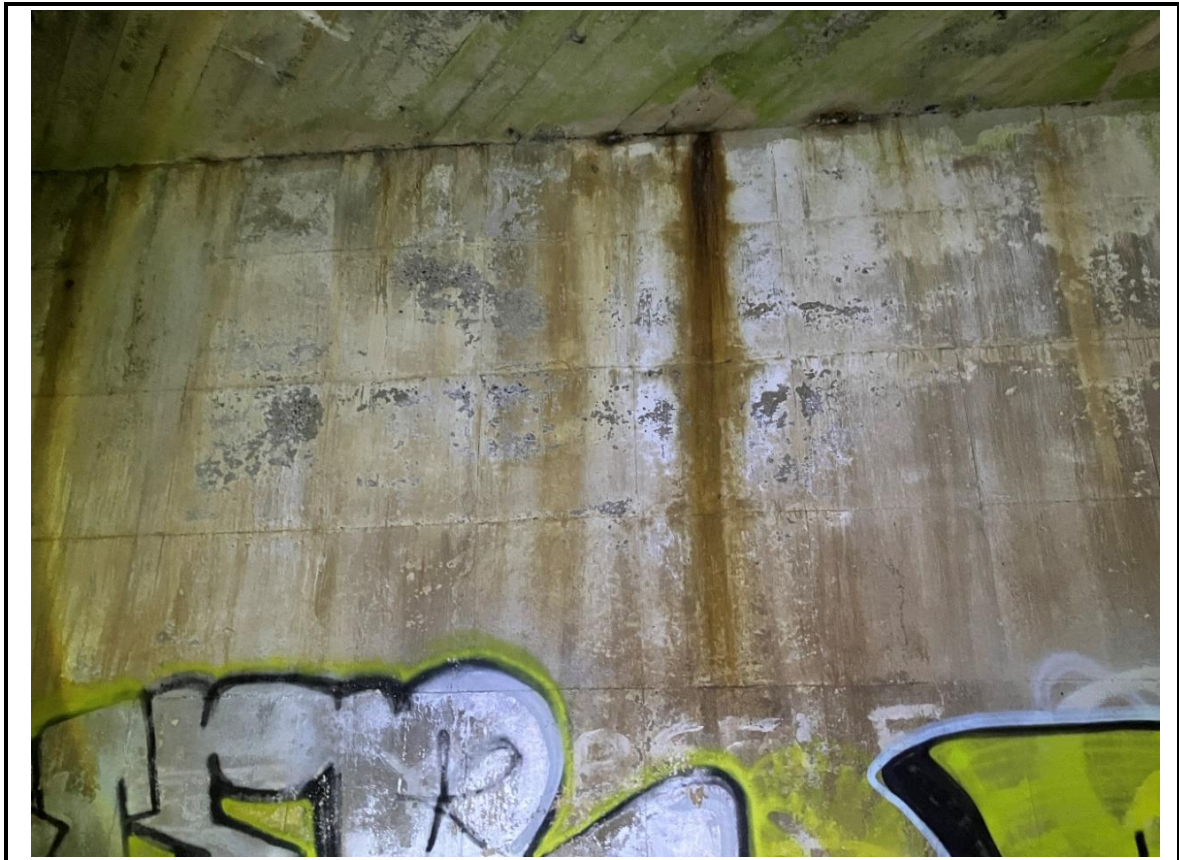
1717_P20_2024 West abutment - Saline leaching and corrosion staining

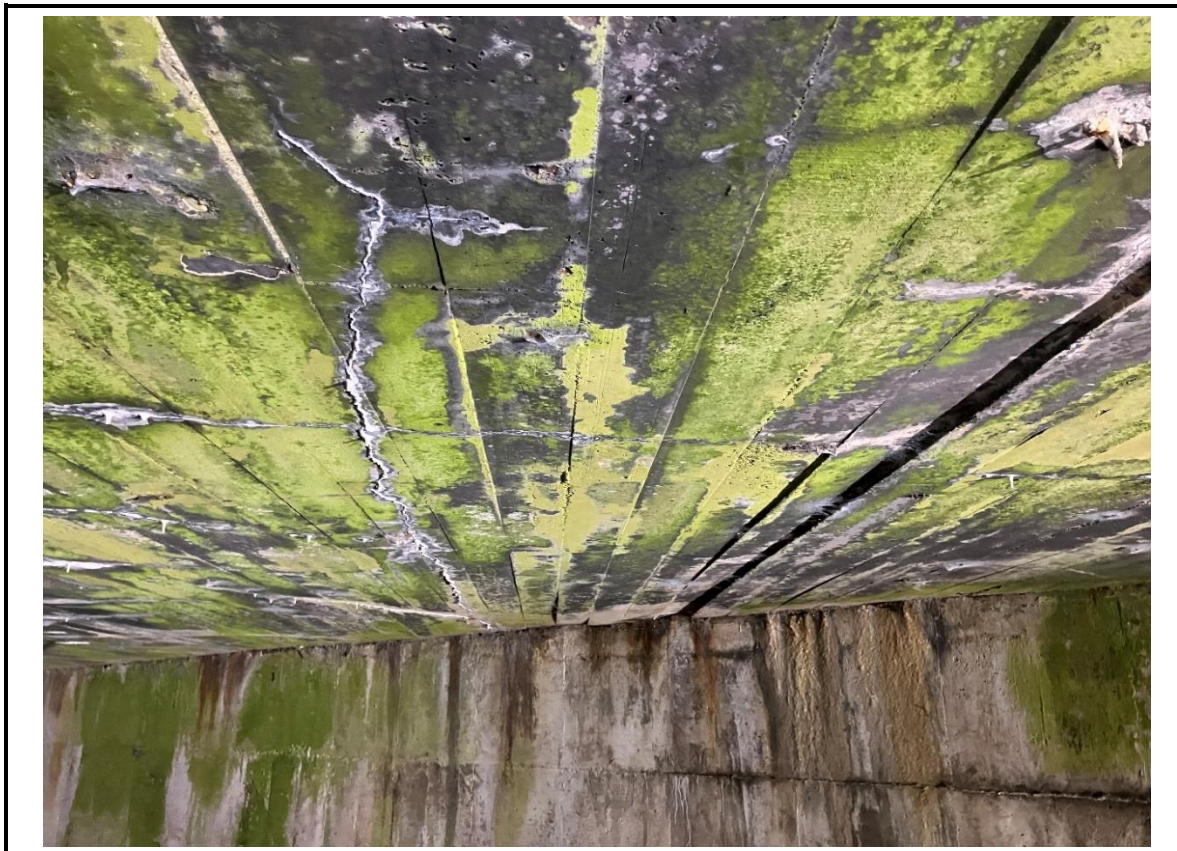
1717_P22_2024 East abutment - Saline leaching and corrosion staining

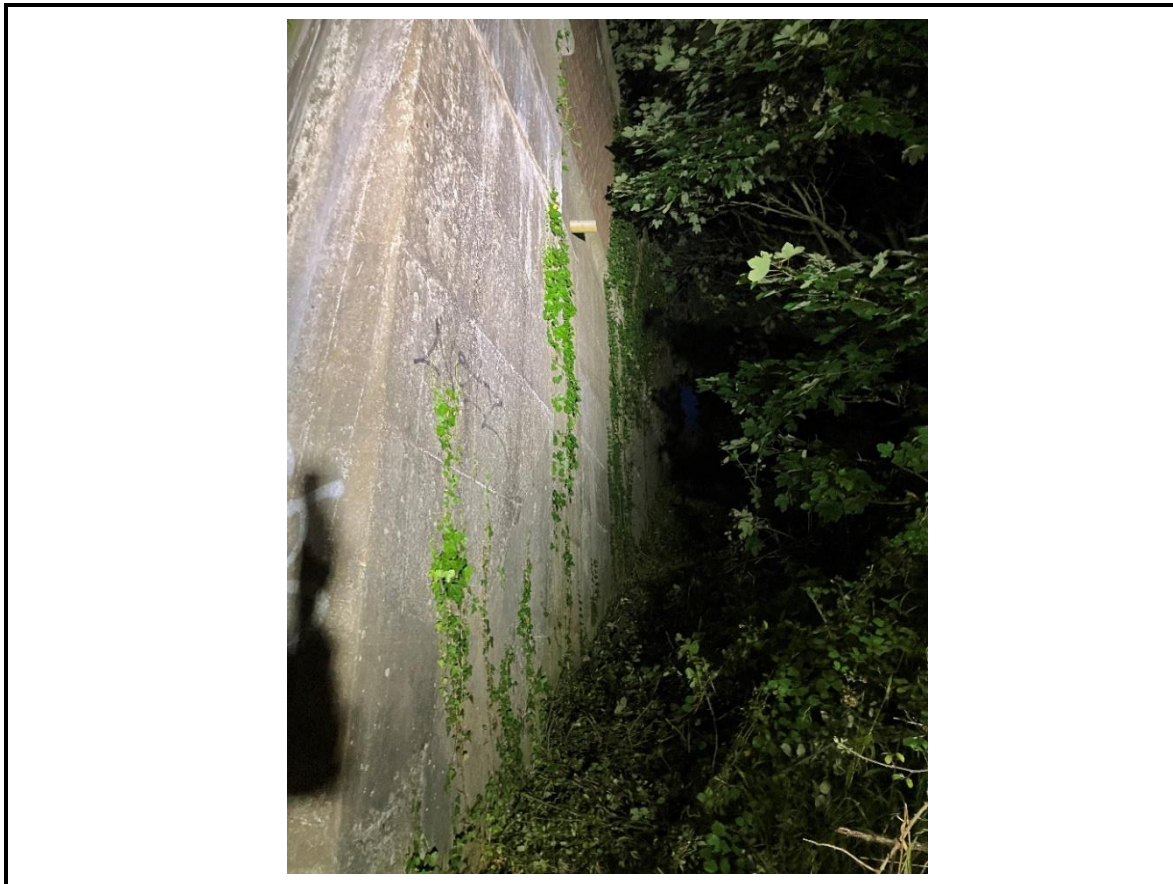
1717_P29_2024 Southeast wingwall - Weephole detail & vegetation growth

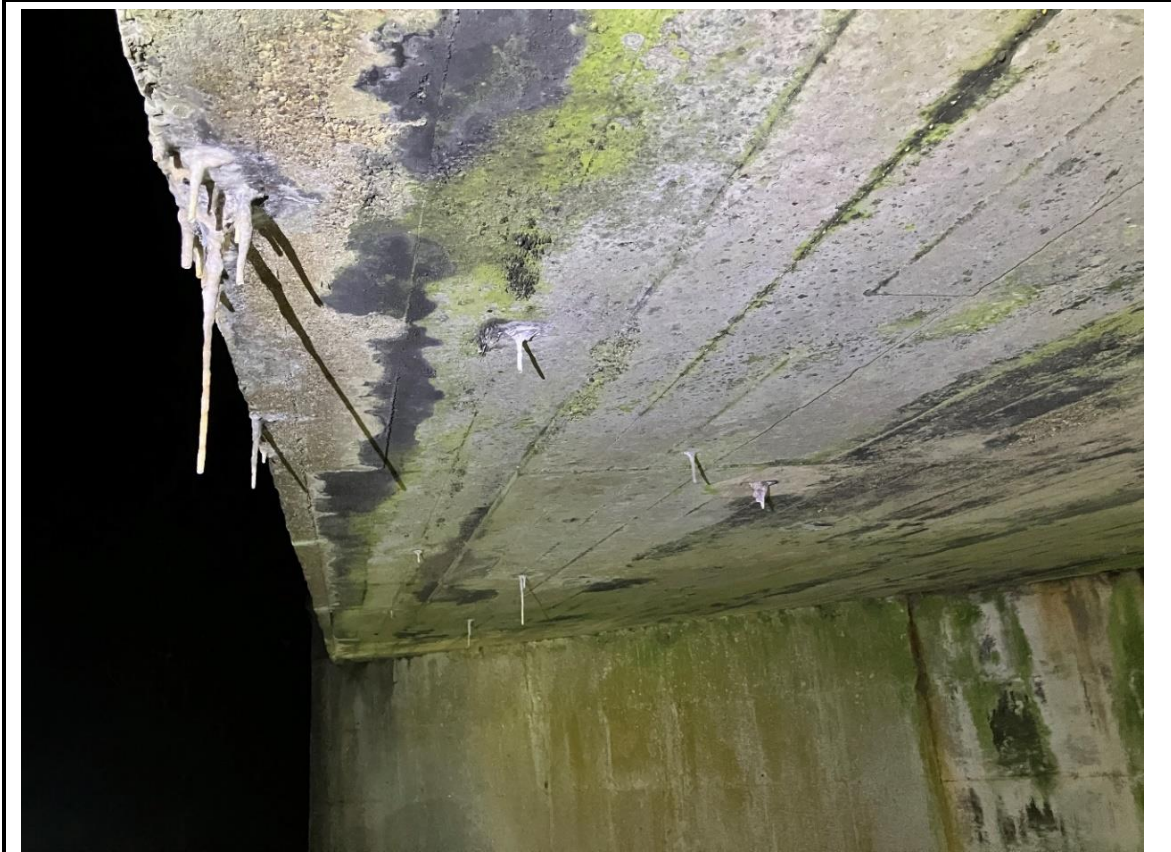
The leaching identified to the deck is likely a result of failure or absence of the waterproofing membrane. It is recommended that the deck is re-waterproofed to eliminate water/moisture percolation through the deck.

1717_P30_2024 Bridge soffit/Edge beam (North footway) - Stalactite formation (<200mm)

Re-waterproof bridge deck.

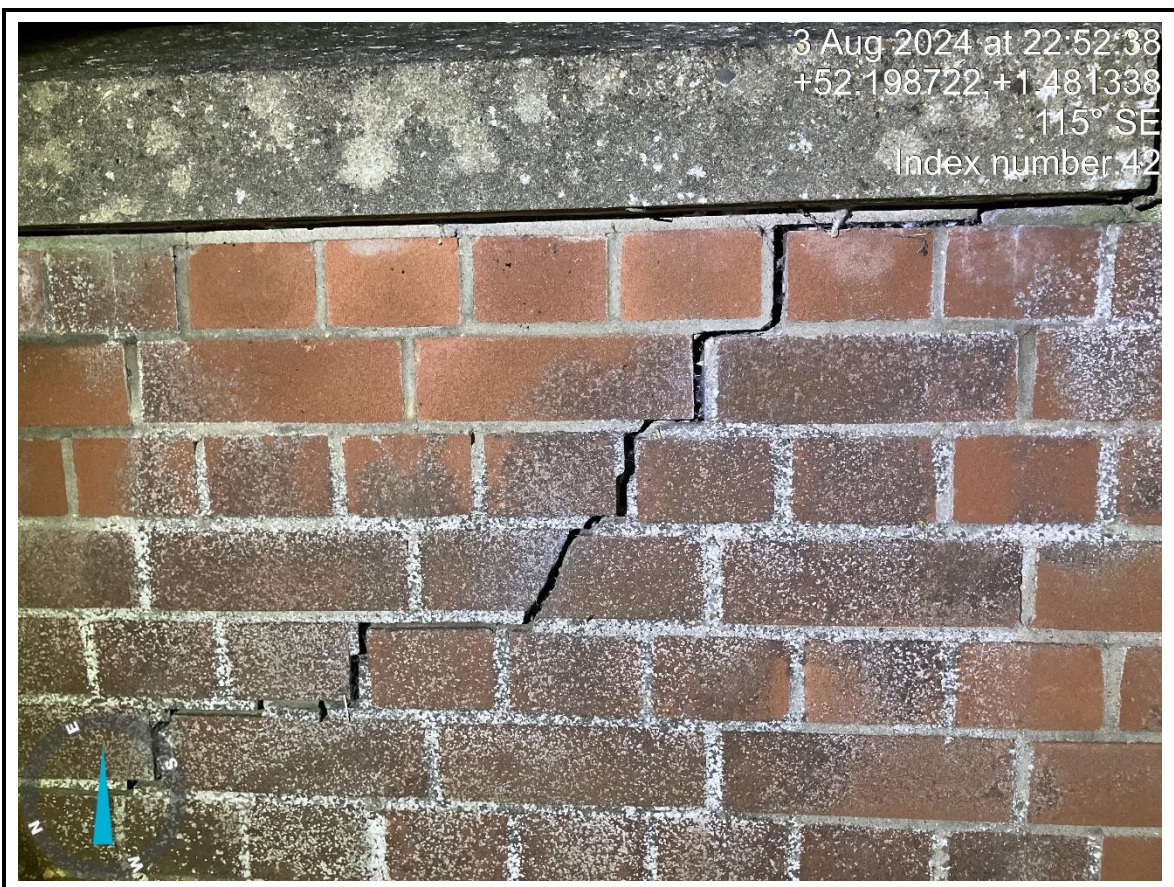
1717_P33_2024 South parapet - Diagonal parapet crack (<10mm)

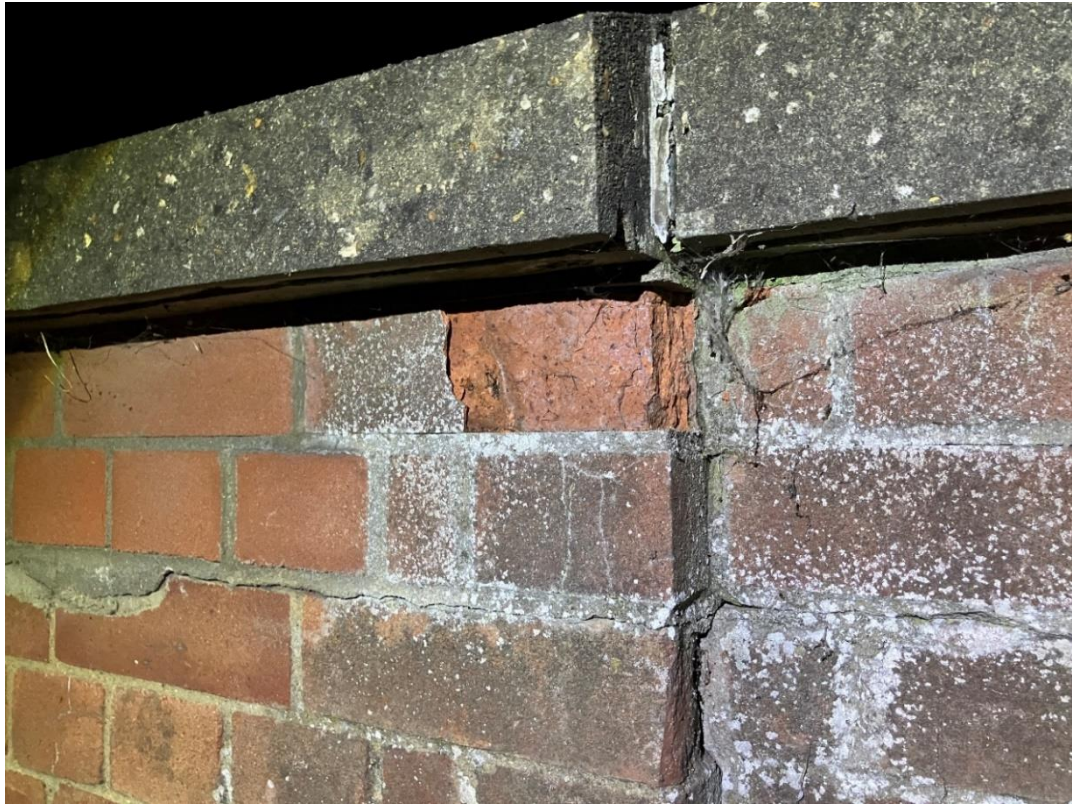
1717_P34_2024 South parapet - Brick spalling (10mm deep) & horizontal hairline crack

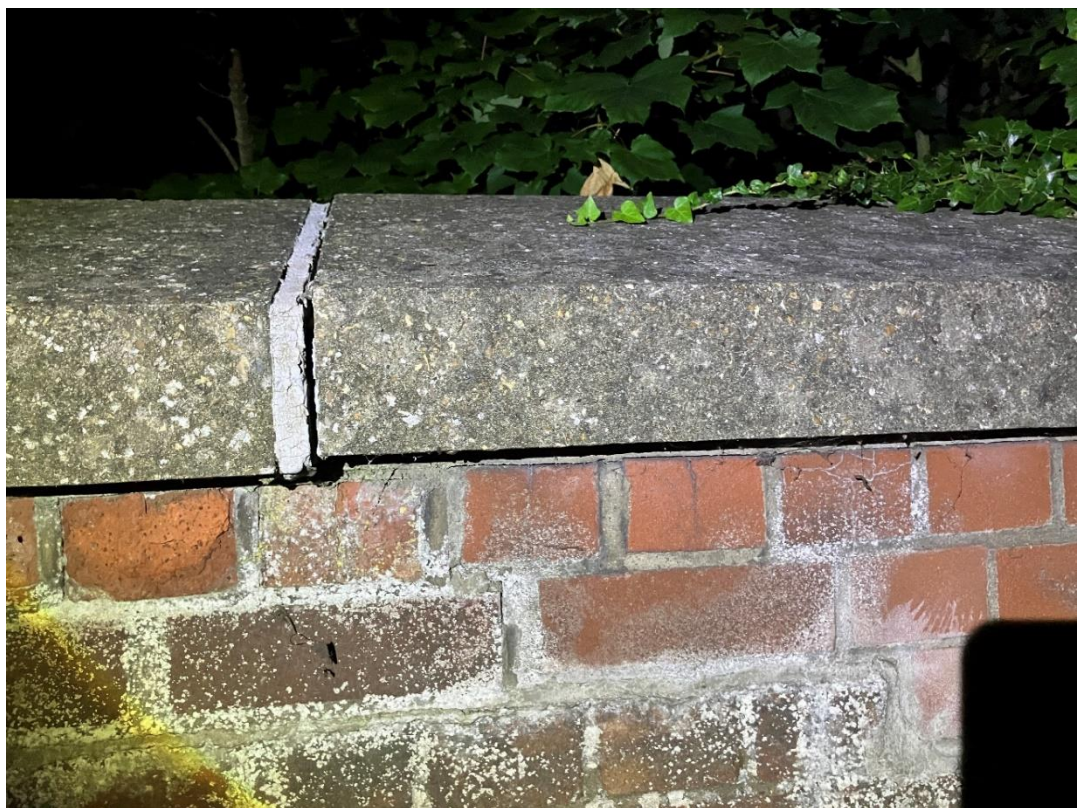
1717_P35_2024 South parapet – Displacement of parapet coping (<15mm) & repaired diagonal crack

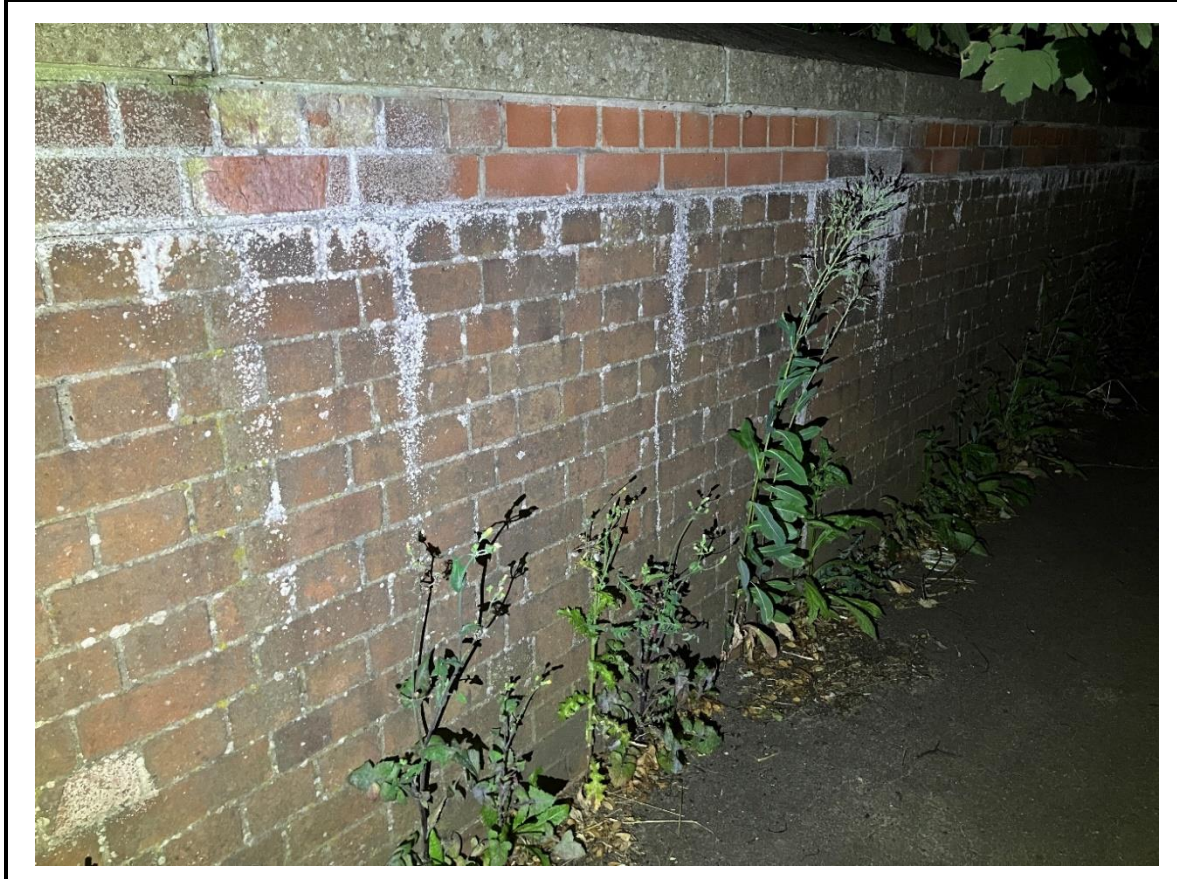
1717_P36_2024 South parapet - Minor vegetation growth & historic leaching

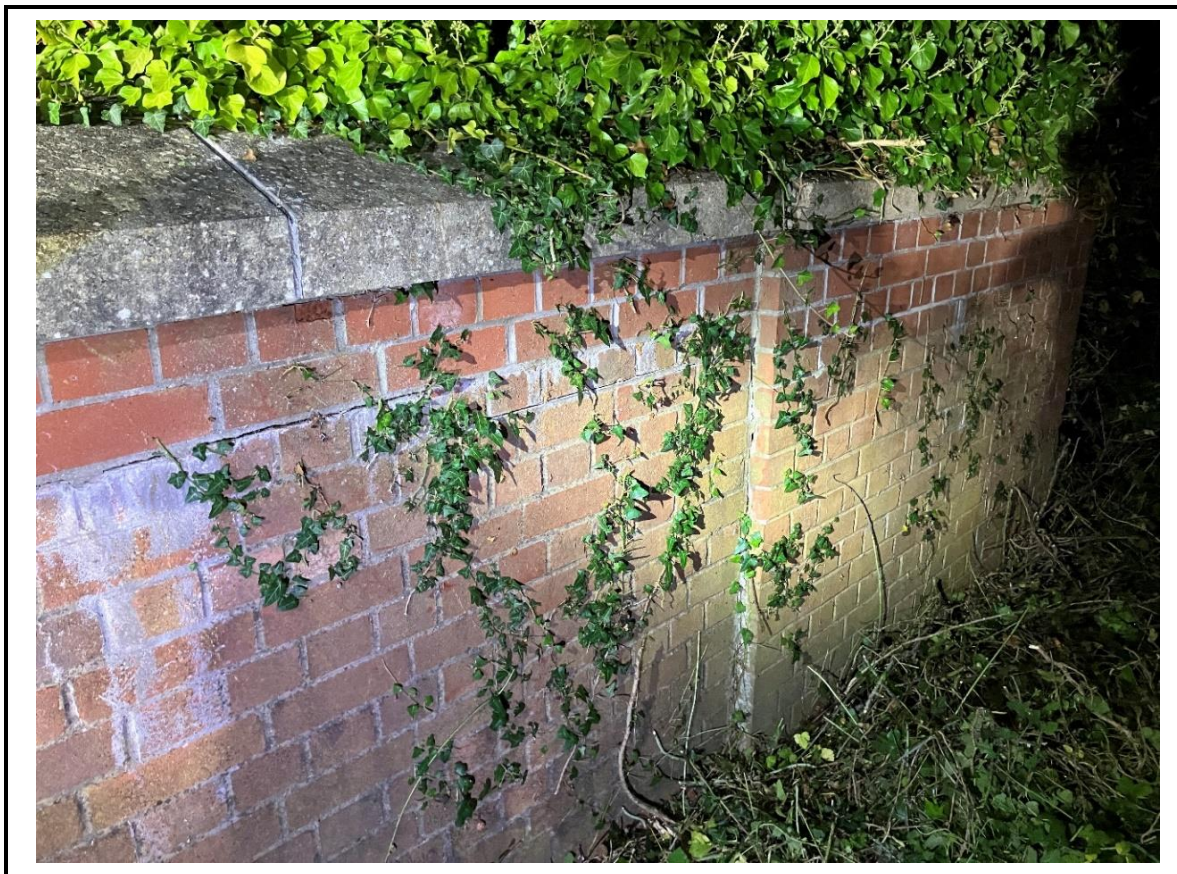
1717_P37_2024 North parapet – Horizontal crack (<2mm), footpath & vegetation growth

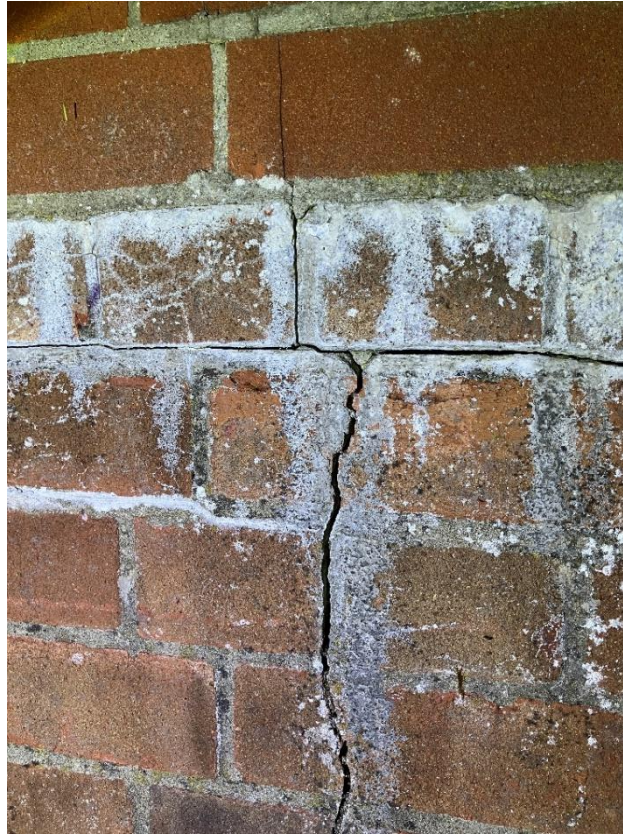
1717_P38_2024 North parapet - Vertical crack (<2.5mm), horizontal crack (<3mm) & leaching

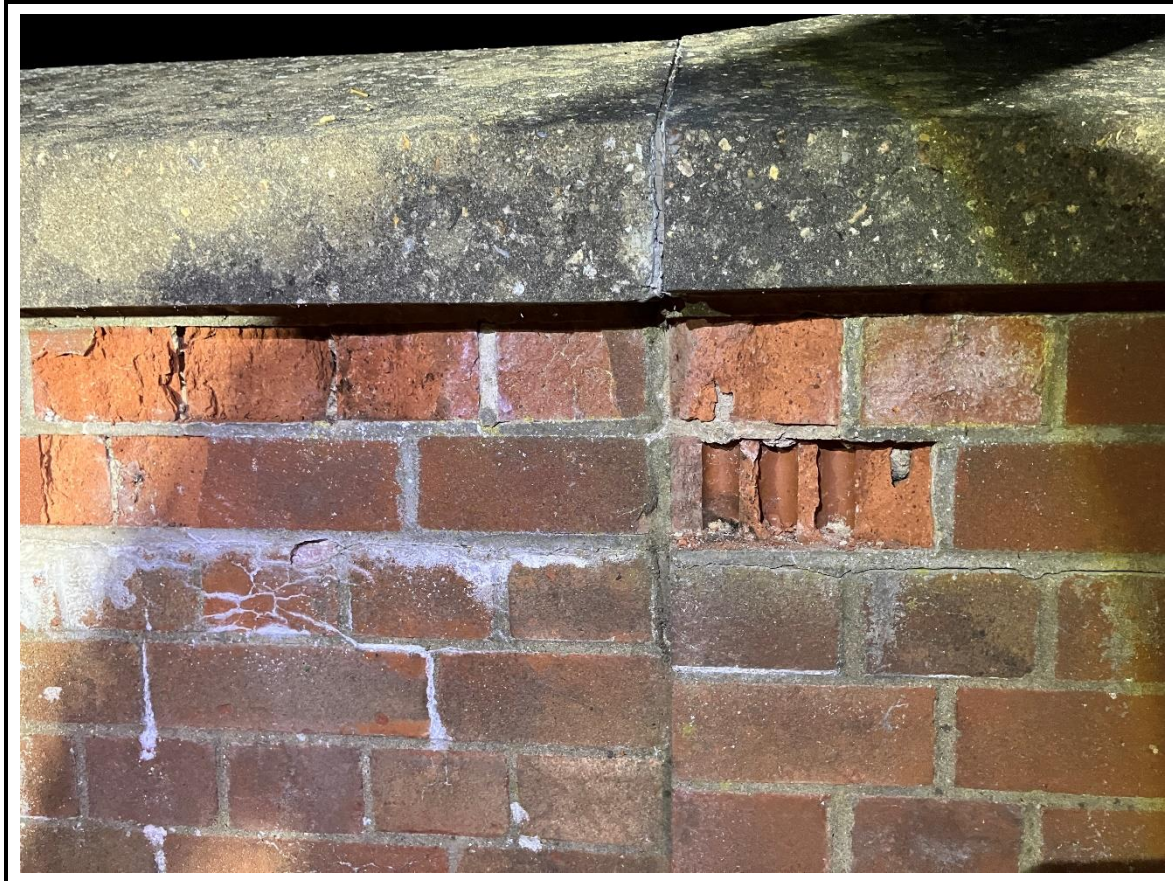
1717_P40_2024 North parapet - Brick spalling & hairline cracks

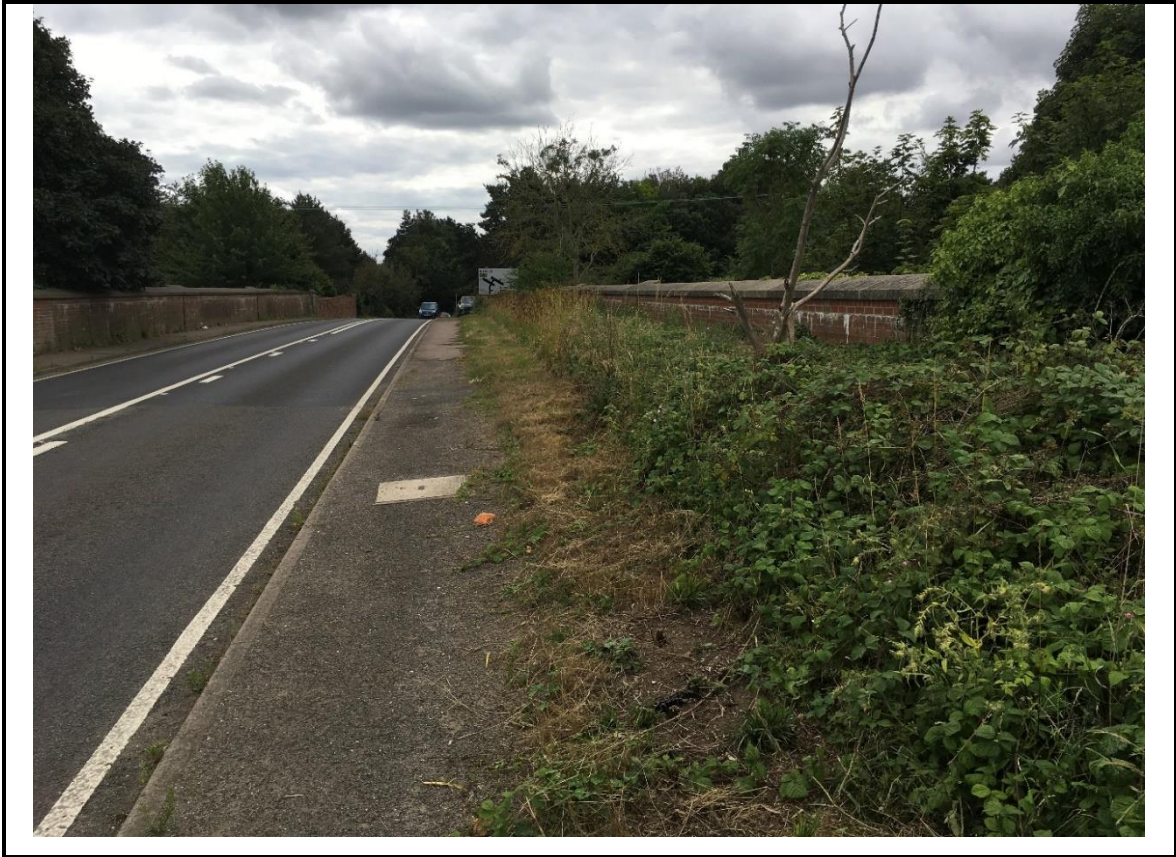
1717_P43_2024 North footway - Footway surfacing and vegetation growth (July 2023)

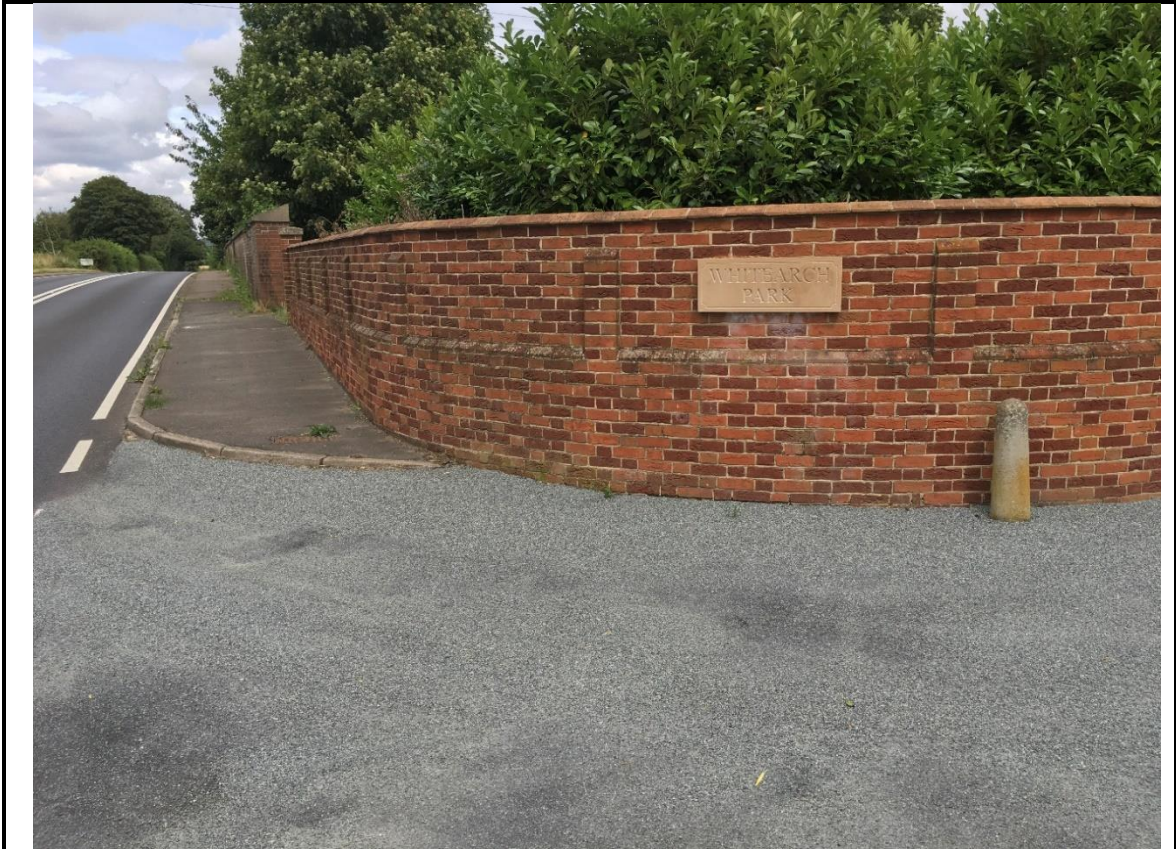
1717_P44_2024 – South footway - Footway surfacing (July 2023)
