Sea Link Grid Reinforcement
Pre-Submission Engagement
Suffolk County Council Response

January 2025

Sea Link Pre-Submission Engagement
Suffolk County Council Response
Appendix C: Benhall Railway Bridge
Principal Inspection Report

**BENHALL RAILWAY BRIDGE
BRIDGE No. 59/42
(BRIDGE CODE 1717)
BENHALL**

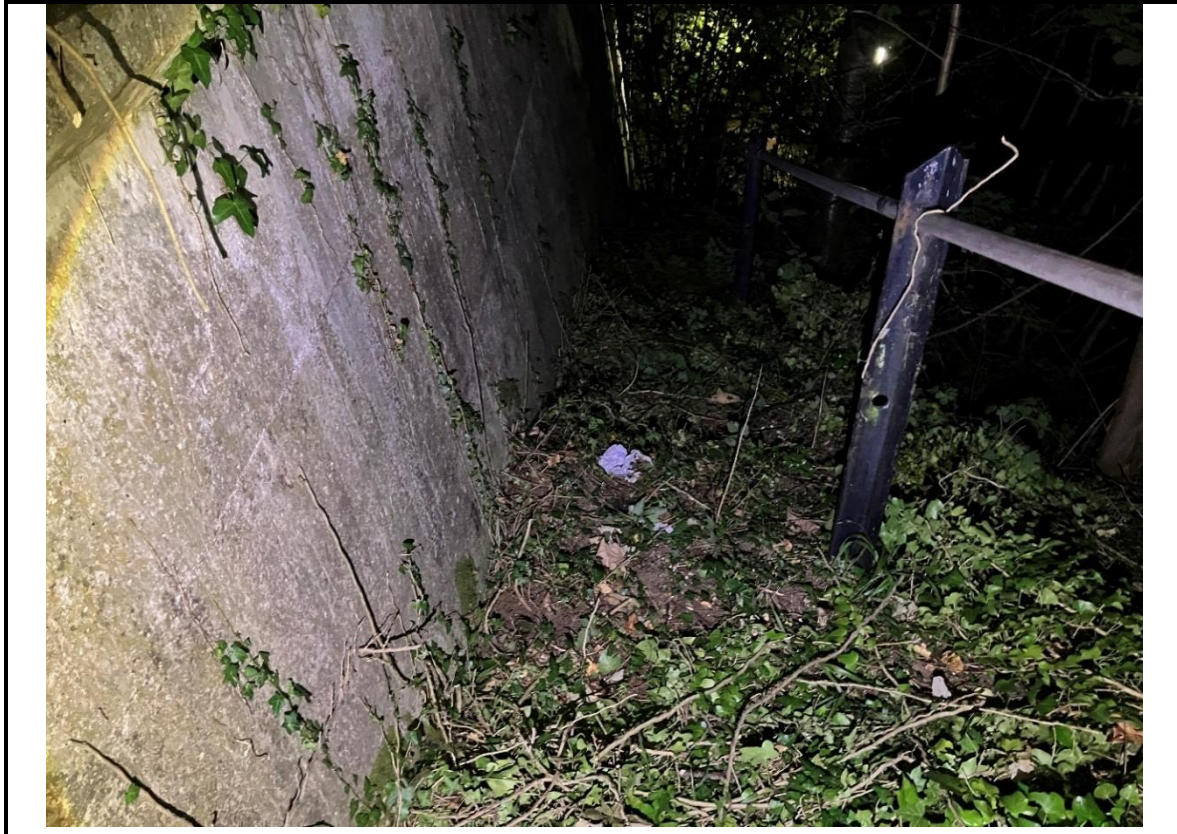
1717_P45_2024 Southwest wingwall - Leaching & vegetation growth

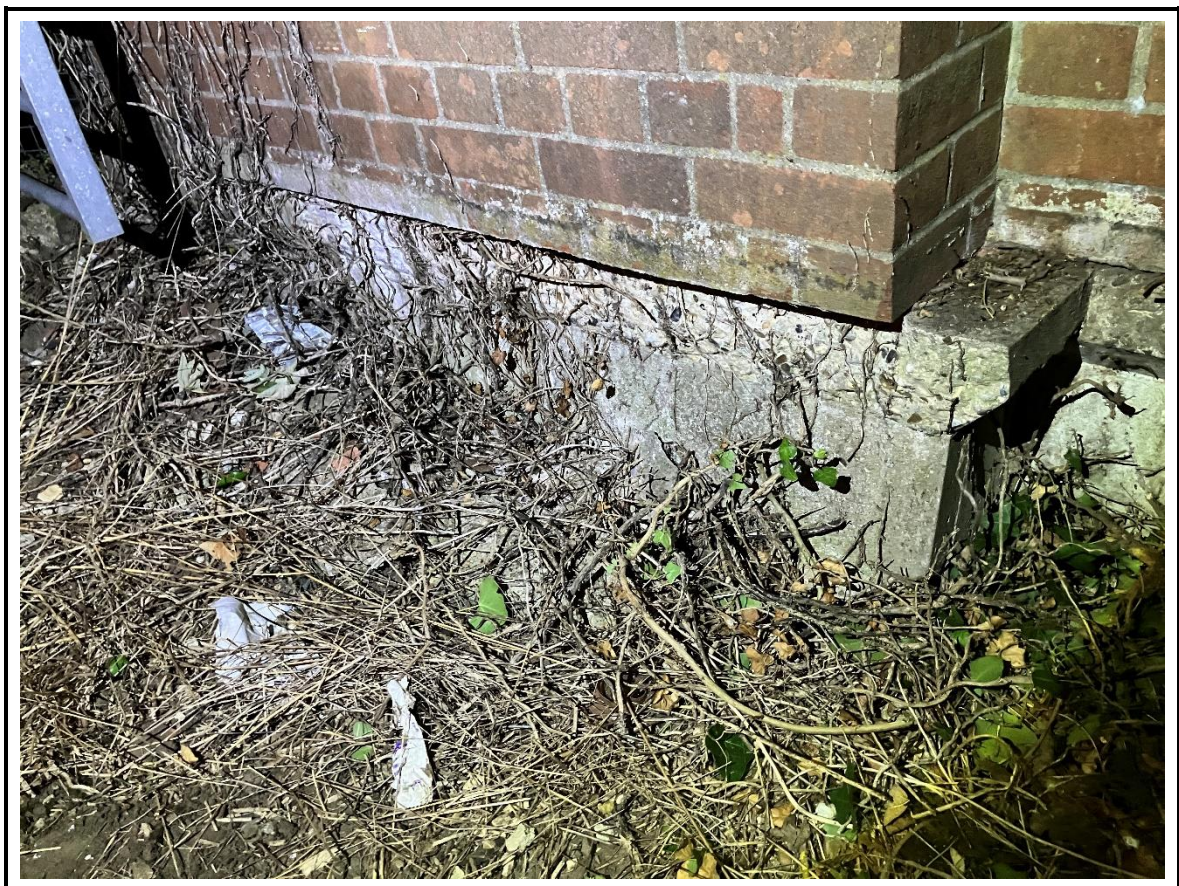
1717_P48_2024 Southwest pilaster - Concrete spalling (<75mm) below pilaster

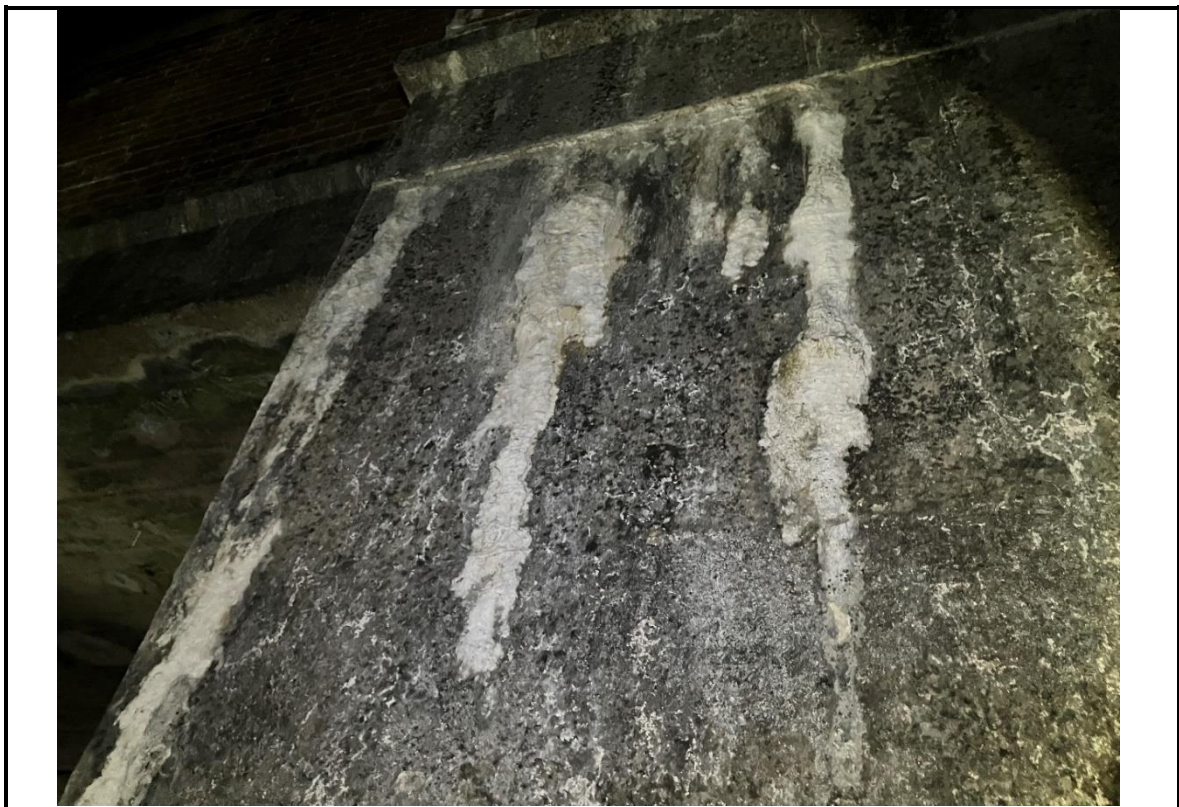
1717_P54_2024 Northwest wingwall - Active saline leachate deposits (<15mm)

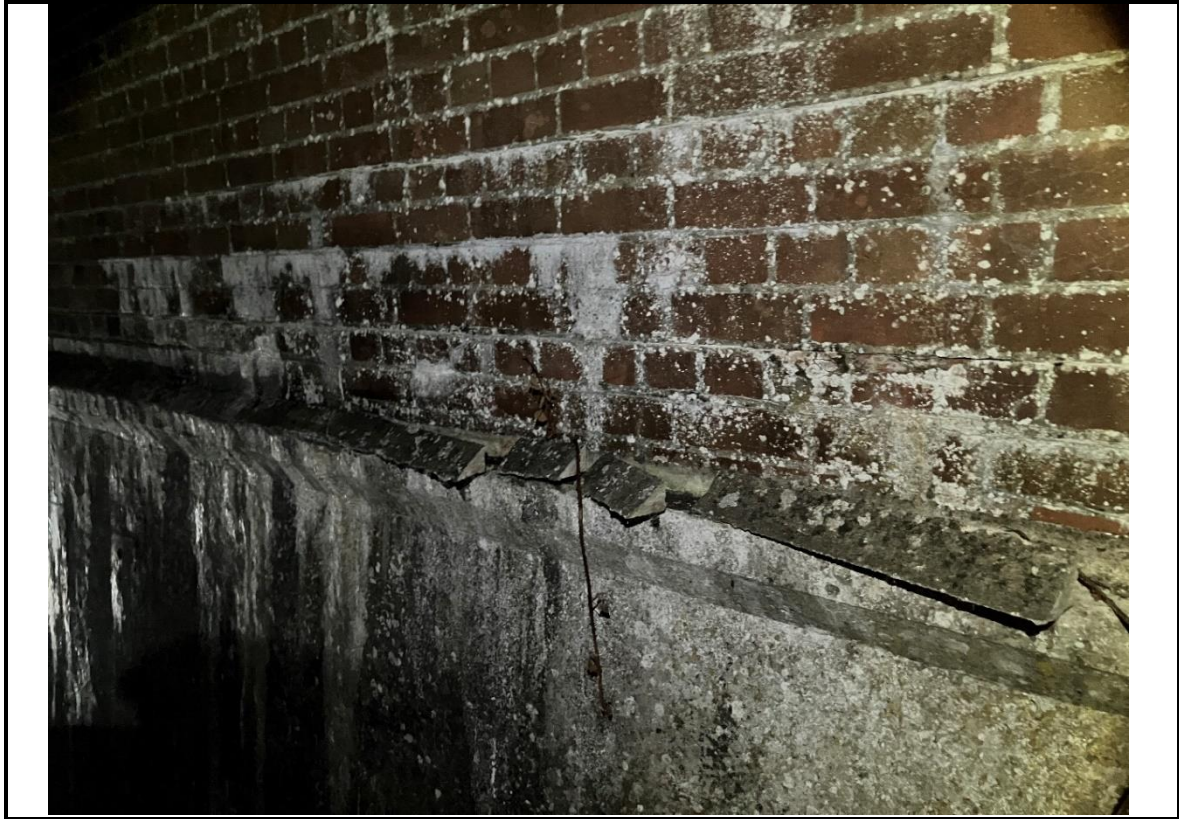
1717_P55_2024 Northwest wingwall - Mortar fillet peeling off

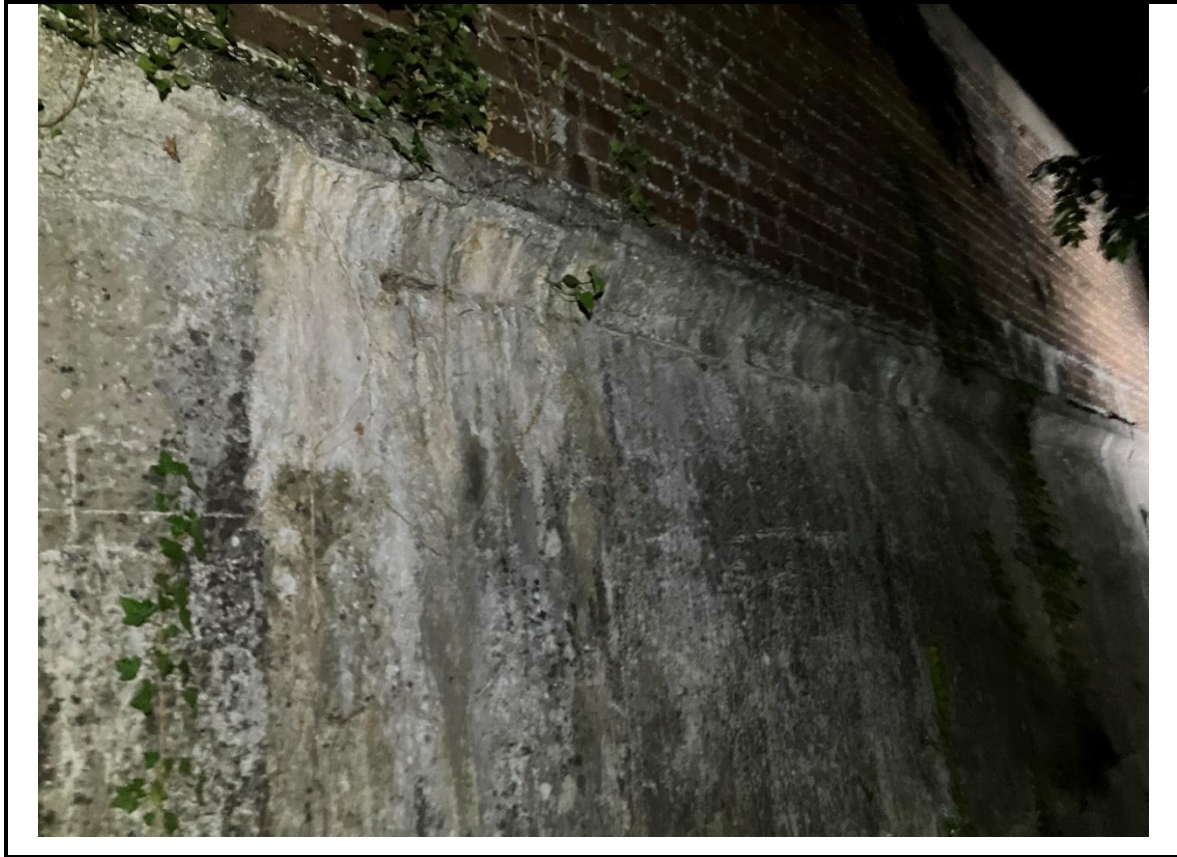
1717_P57_2024 Northeast wingwall - Active saline leaching

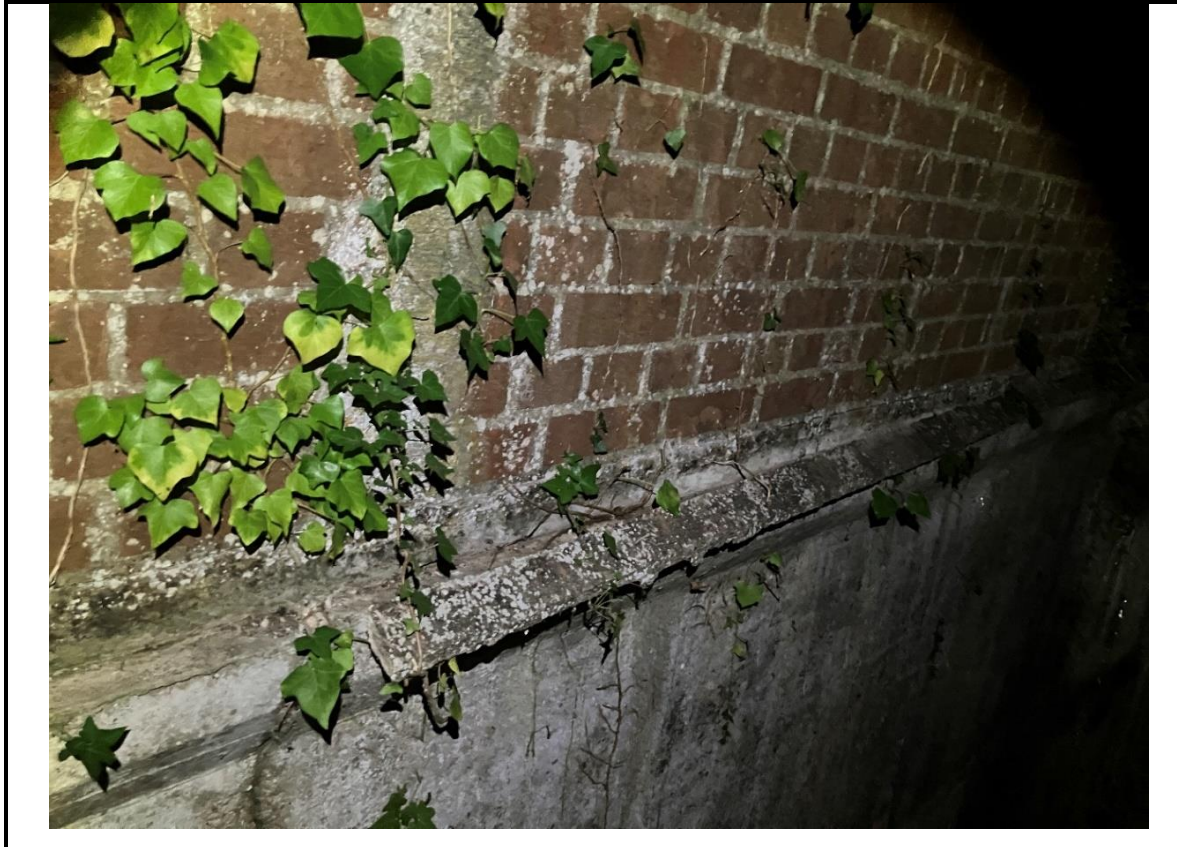
1717_P58_2024 Northeast wingwall - Mortar fillet peeling off
