Sea Link Grid Reinforcement
Pre-Submission Engagement
Suffolk County Council Response

January 2025

Sea Link Pre-Submission Engagement
Suffolk County Council Response
Appendix C: Benhall Railway Bridge
Principal Inspection Report

**BENHALL RAILWAY BRIDGE
BRIDGE No. 59/42
(BRIDGE CODE 1717)
BENHALL**

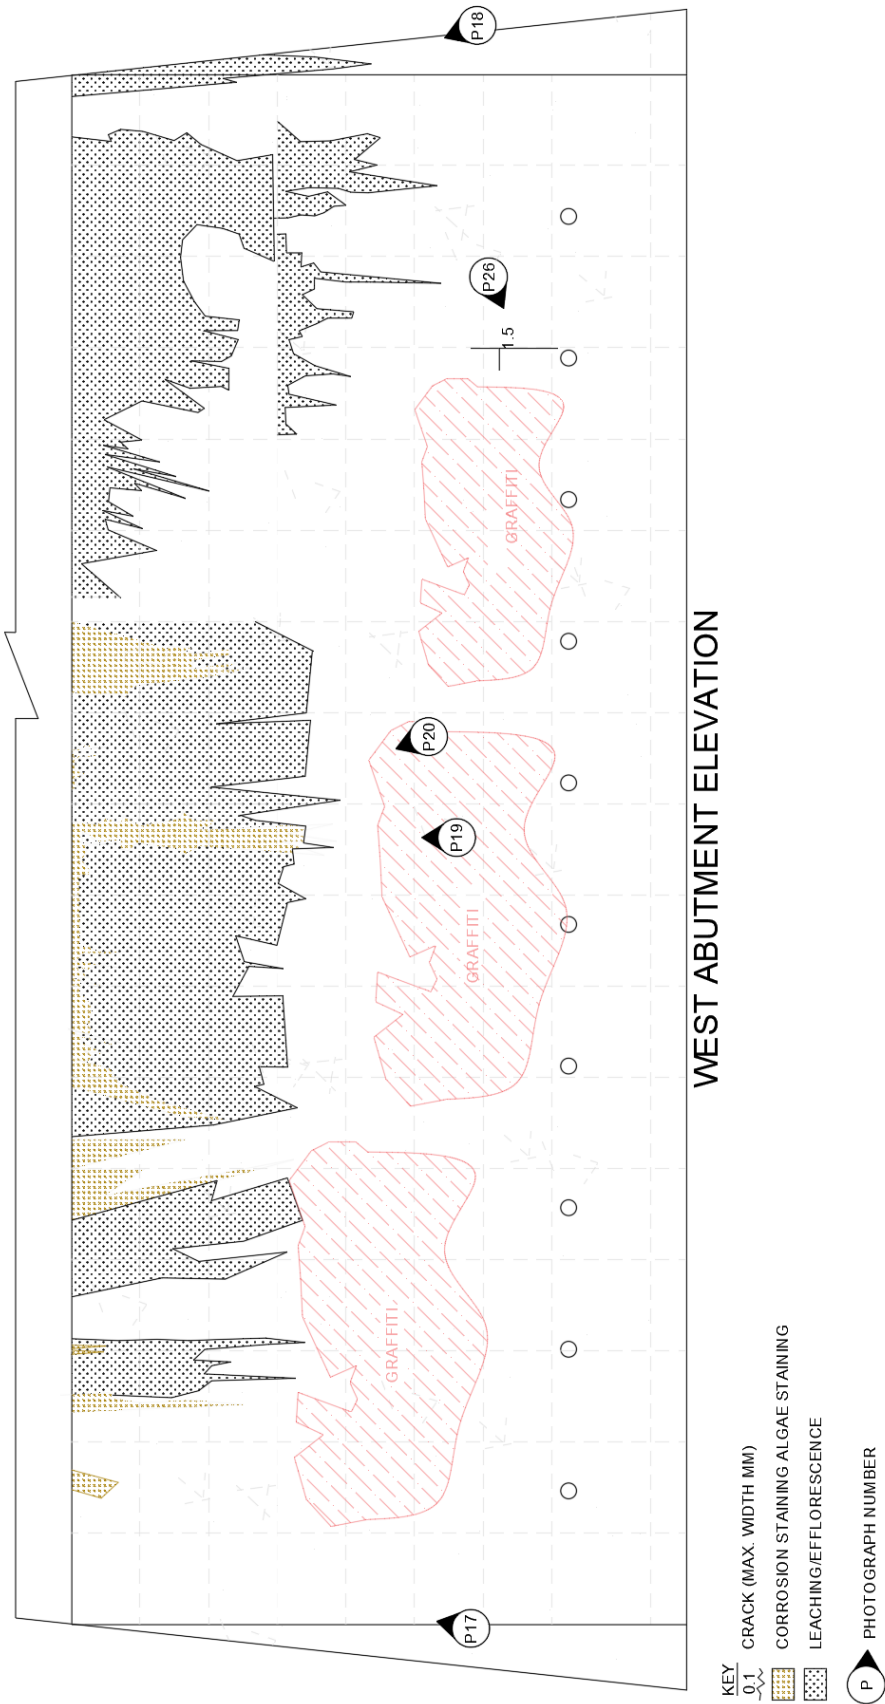
DIAGRAM D2 – WEST ABUTMENT
Not to scale

Significant saline leaching and corrosion staining observed at the top of both abutments.

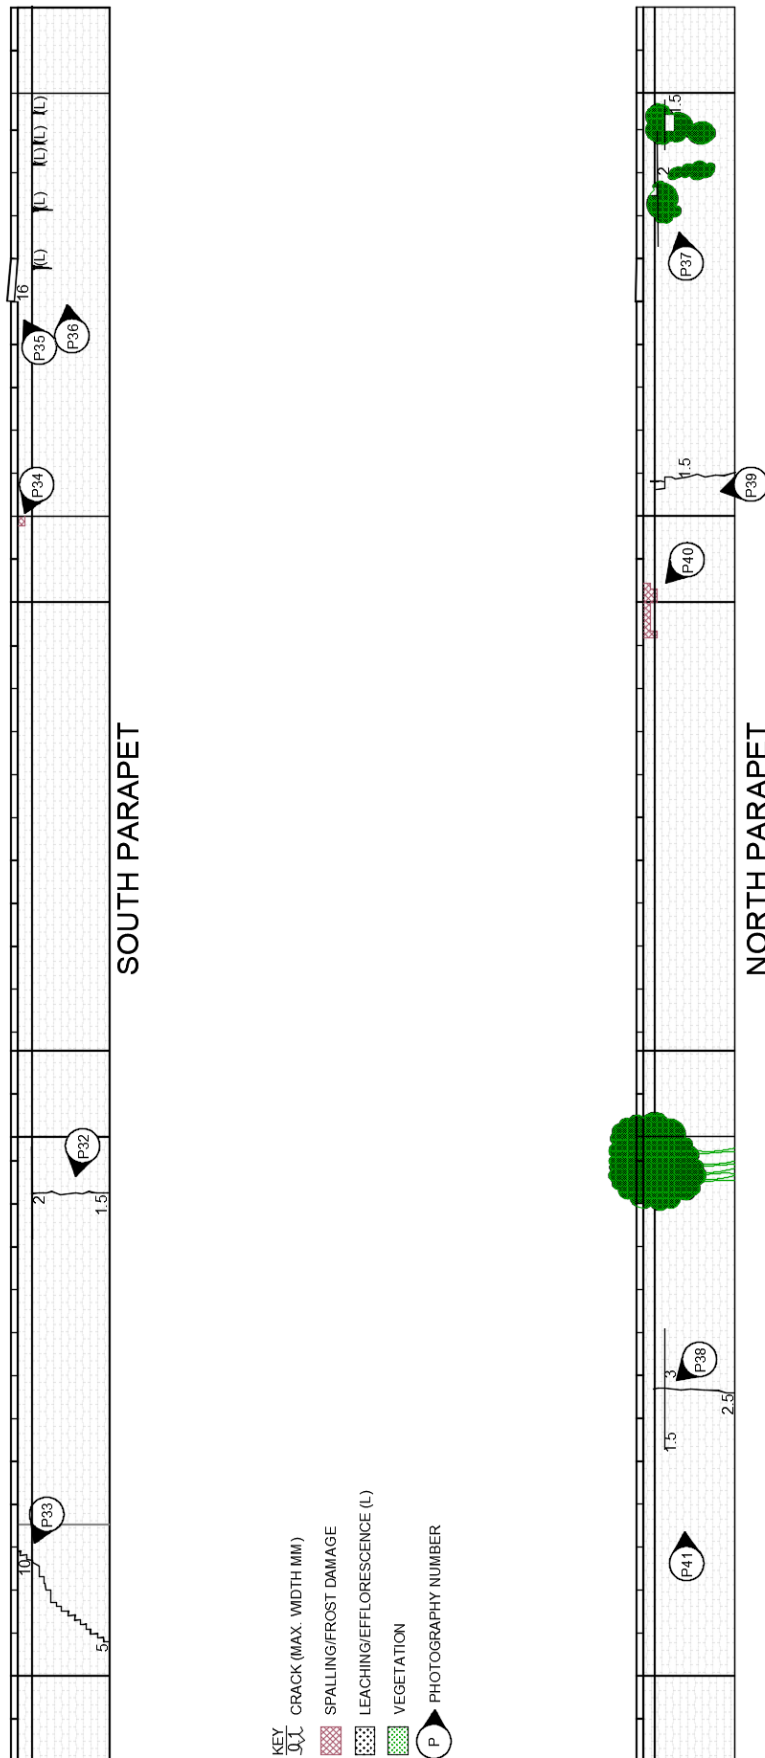
DIAGRAM D4 – NORTH & SOUTH PARAPET
Not to Scale

- Carriageway surfacing had potholes and major weathering throughout.
- Displacement was noted to the west end of south brickwork parapet. Numerous minor cracks and spalls noted throughout both parapets. Ivy growth to both parapets.

Remove vegetation from parapets prior to next Principal Inspection.
